Subject: Trip Report
Marino Property
Middletown, Connecticut
CERCLIS No. CTD062199369
State ID No. 950
TDD No. 06-07-0002

**TRIP REPORT
FOR
MARINO PROPERTY
SITE REASSESSMENT
MIDDLETOWN, CONNECTICUT**

CERCLIS NO. CTD062199369
STATE ID NO. 950
TDD NO. 06-07-0002
TASK NO. 0213
DC NO. A-6247

6 April 2007

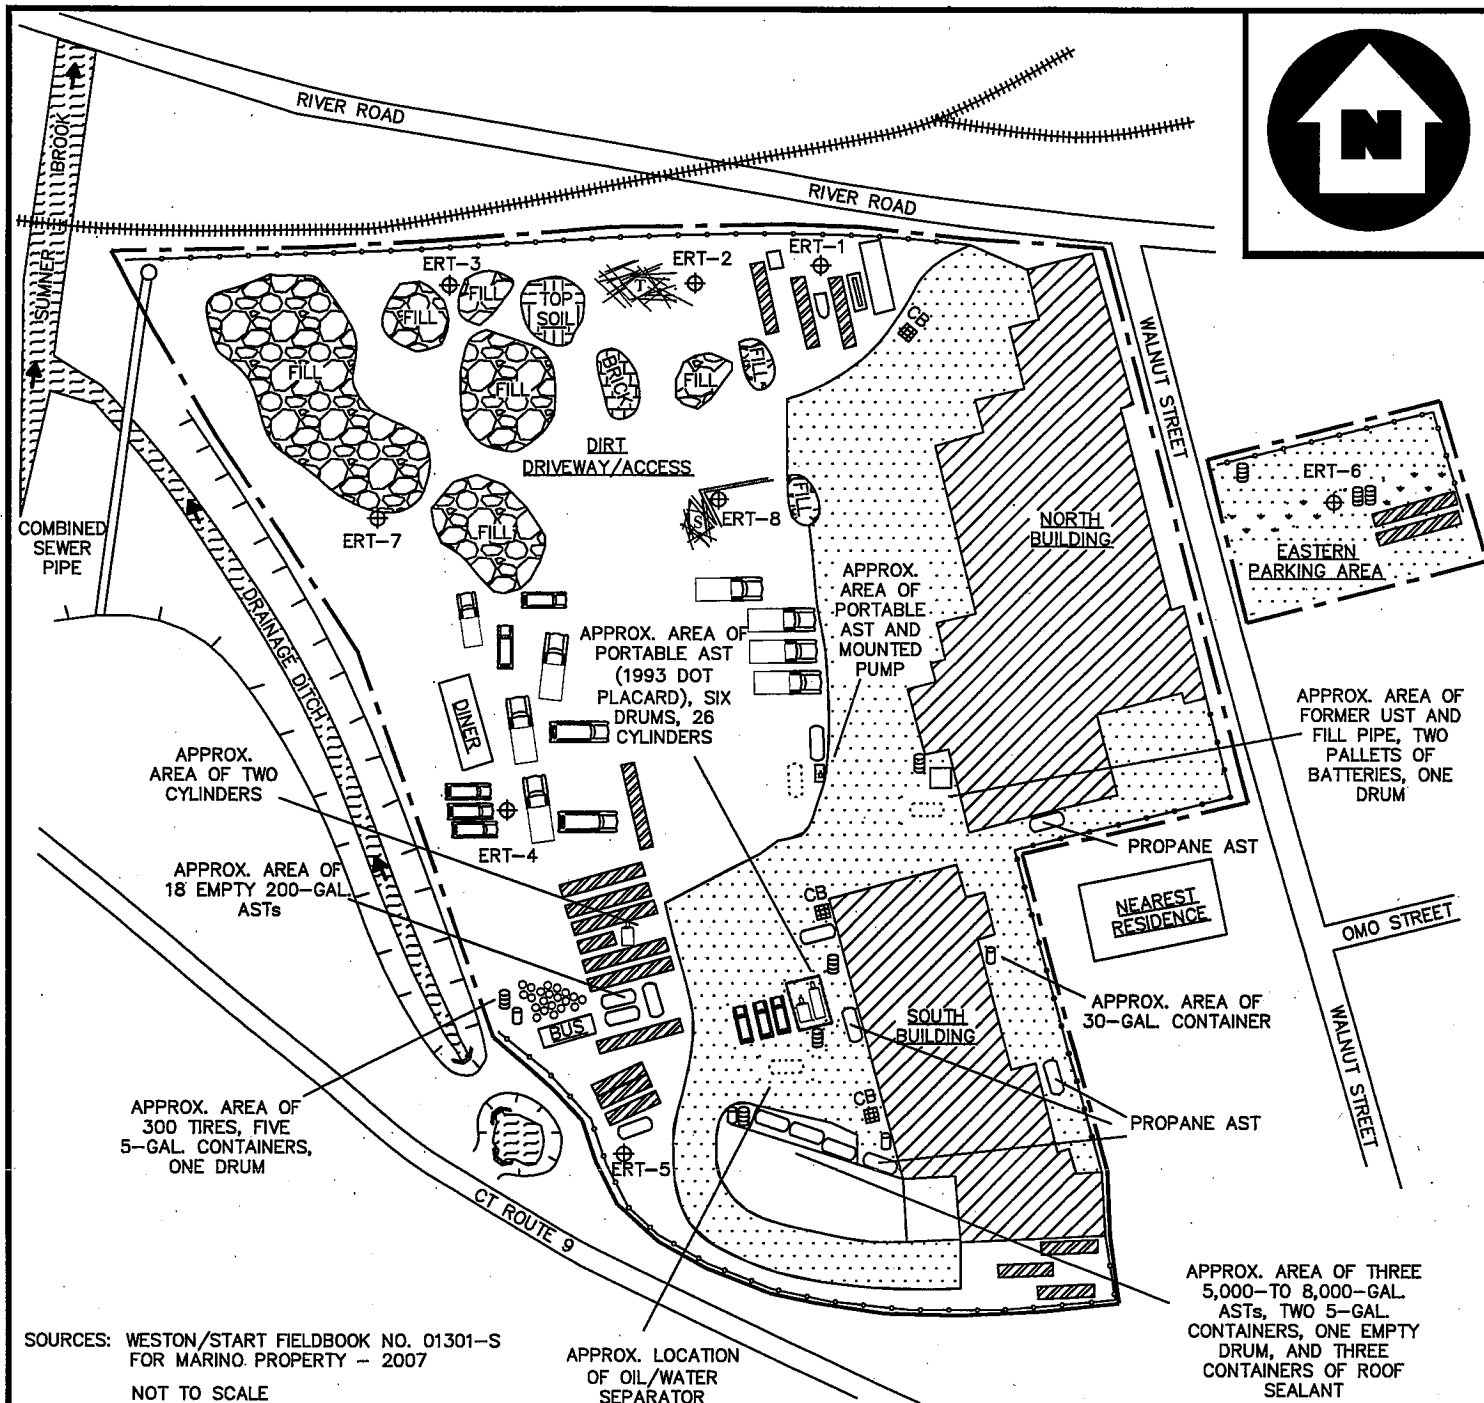
FIGURE 2

START personnel observed the former landfill area on the western portion of the property. There was no evidence of current disposal activities. START could not determine the exact extent of the former landfill but observed the presence of a steep slope at the western boundary of the property. The top of the former landfill is flat. Based on observations made during the reconnaissance, groundwater appears to flow east to west through the landfill area, emptying into the drainage ditch along the side of the property (see Figure 2).

Along the northern border of the property, START personnel observed three truck trailers, a boat, a billboard sign, a mobile home, and a truck-mounted refrigerator. At the entrance to the parking area, START observed a petroleum sheen on water flowing into a storm drain. The water with the sheen was observed by START to originate near the garage door on the southwestern corner of the North Building, and flowed north along the parking area. To the west of the storm drain, START personnel also observed piles of brick, timber, topsoil, and fill containing concrete debris, rock, gravel and sand material. These piles continued to the northwestern corner of the property. At the northwest corner of property, behind the largest fill pile, START observed an extended manhole accessway to a 3-foot-diameter combined sewer pipe extending from the corner of the property to the southwest. The pipe appeared to continue to the northeast, connecting to the sewage pumping station located across from the site on River Road. The combined sewer pipe crossed the drainage ditch along the western edge of the property, and a makeshift tarp tent was observed constructed below the pipe where the two meet. This tent appeared to have been formerly used by a homeless person. To the west of the manhole, START personnel observed the location where the drainage ditch discharges to Sumner Brook (see Figure 2).

To the south of monitoring well ERT-8, START observed construction equipment and trucks, a portable AST, and a gasoline pump mounted on a concrete slab. START could not determine whether the AST contained liquid and whether the gas pump was operational (see Figure 2).

To the south of ERT-7, START observed numerous abandoned vehicles, a former diner building, and trailers of various length and size. START personnel observed two cylinders (contents unknown) beneath a trailer to the south of monitoring well ERT-4. To the west of the trailers, START personnel observed approximately 300 tires, a 55-gallon steel drum (contents unknown), and several five 5-gallon buckets (contents unknown). To the west of the drum, START observed a steep embankment which leads to the drainage ditch. The drainage ditch begins along the southwestern portion of the property, where a pipe discharges to a sump, which in turn discharges to the drainage ditch flowing along Route 9. The drainage ditch extends north-northwest to Sumner Brook (see Figure 2).

To the southeast of the tire pile, START personnel observed three trailers, a small camper, 18 200-gallon ASTs, and a bus. The ASTs appeared to be empty; and according to Mr. Marino, they belonged to Mulch Seal. Within the bus, START personnel observed five 30-gallon plastic containers of Plasdene-K29/32, five 5-gallon buckets of unknown material, and miscellaneous construction debris (see Figure 2).

To the south of the bus, adjacent to monitoring well ERT-5, START observed a large stainless steel AST mounted on a flatbed construction trailer. According to Mr. Marino, the AST had not been used by its owner, Mulch Seal (see Figure 2).

Along the exterior western wall of the South Building, START observed a portable AST with attached containment basin and an attached DOT placard (1993). START observed three 55-gallon steel drums staged on a pallet, two of which were full with an unknown liquid. START personnel observed a fenced area, which was secured with a chain and lock, containing 24 20-pound/5-gallon propane cylinders and two larger propane cylinders, three unmarked 55-gallon steel drums (contents and volume unknown), and a 500-gallon propane tank. Adjacent to the South Building entrance used by Mulch Seal, START personnel observed three 1-gallon cans of crack sealant, one 500-gallon propane tank, three 5,000- to 8,000-gallon ASTs surrounded by a containment basin, one 55-gallon steel drum (empty and without a cover), and two 5-gallon buckets. According to the property owner, the catchbasin in this area is piped to an underground oil/water separator (see Figure 2).

Along the southwestern wall of the North Building, START observed a tarp-covered trailer which contained potential ACM wrapped in plastic sheeting and sealed with tape, one 55-gallon steel drum (contents and volume unknown), two pallets of lead/acid batteries, and a steel housing which enclosed a fill pipe for a UST. START personnel could not verify the size or contents of the UST or whether it was still operational (see Figure 2).

Along the south wall of the North Building, START observed a propane tank which appeared to be in use. Along the eastern wall of the South Building, START personnel observed a 30-gallon container with unknown contents (see Figure 2).

To the east of the North Building, east of Walnut Street, START personnel observed a paved parking area, owned by Mr. J.R. Marino, containing three 55-gallon steel drums, one of which was full of an unknown material while the other two were empty. According to Mr. Marino, the full drum was dropped off illegally on the property. START personnel observed monitoring well ERT-6 in the middle of the parking area (see Figure 2).

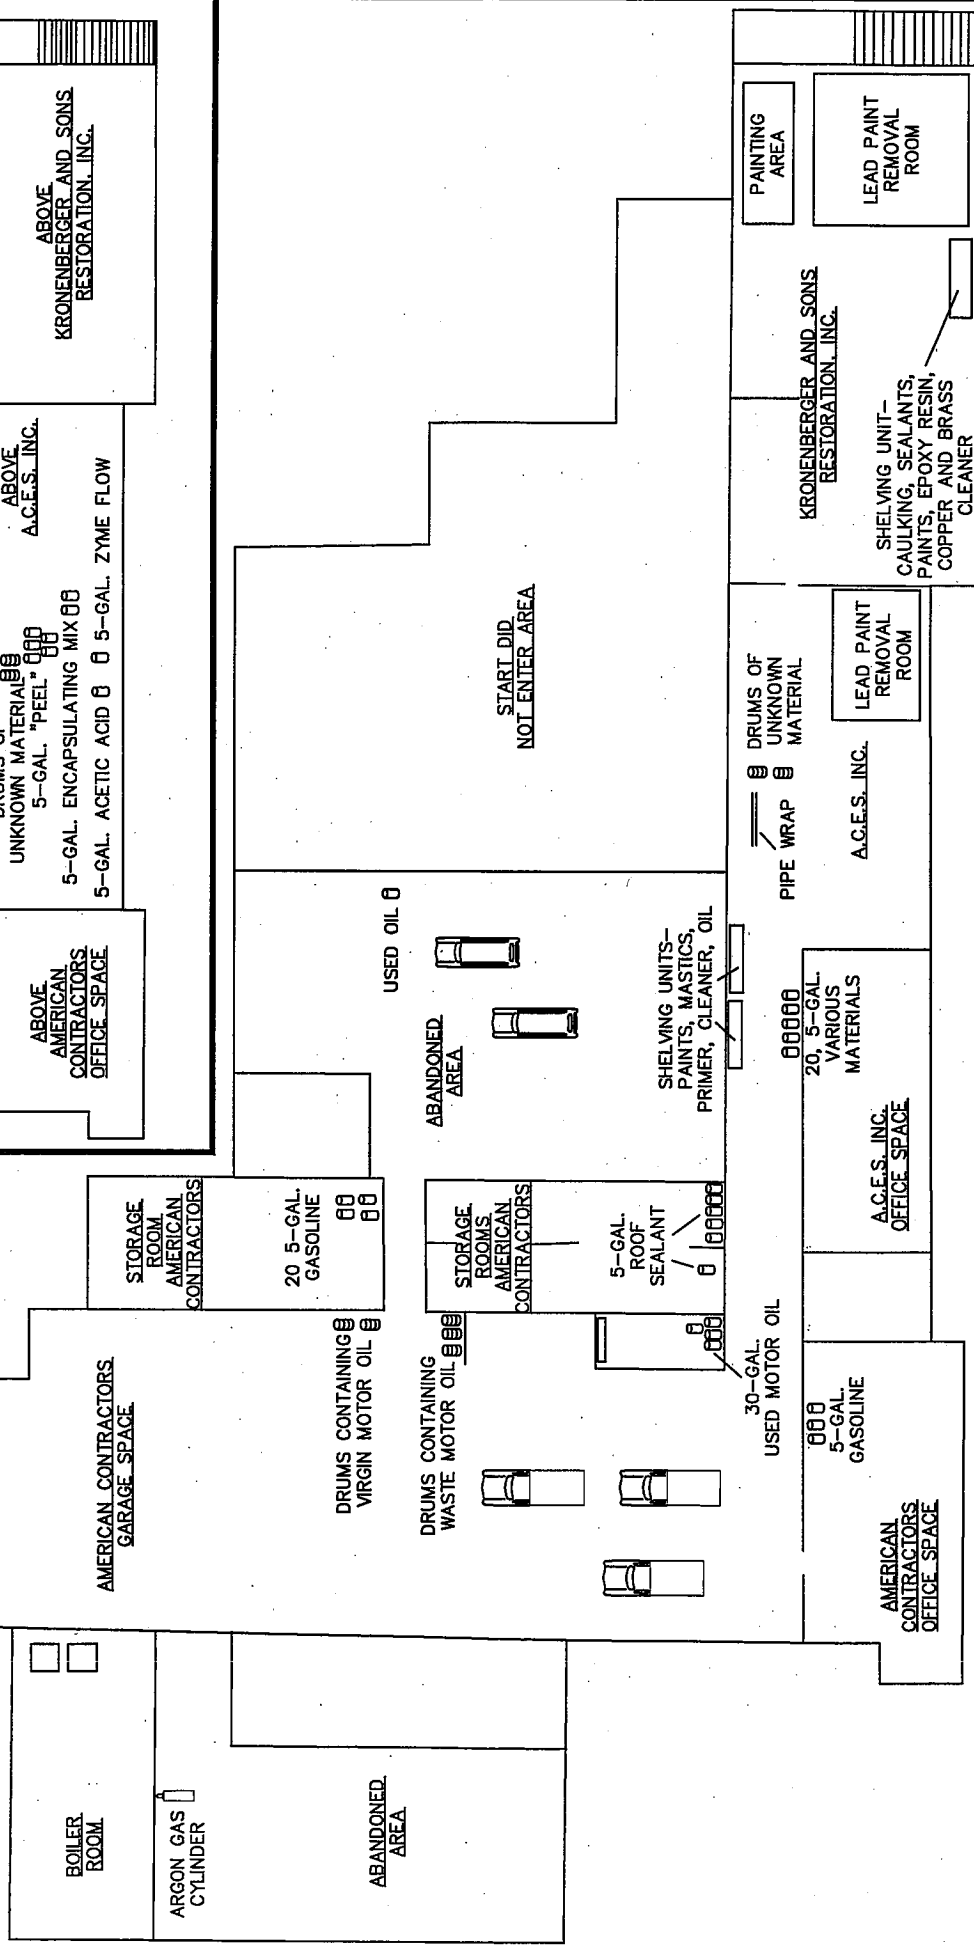
FILE NAME: S:\06070002\Figures & Maps\ Figure_4_North_Building
 FIGURE 4

The southern portion of the North Building is occupied by American Contractors LLC, the company operated by Mr. Marino. The area contains a large garage area with attached storage rooms and an office area. START personnel observed three 5-gallon gasoline fuel cans in the office area where air monitoring on the FID ranged between 30 and 40 ppm. Within the garage area, START personnel observed one employee in the process of cleaning engine parts in a vat presumably containing gasoline. Air monitoring equipment readings ranged between 40 and 50 ppm on the FID within this area. Portions of the floor had staining indicative of spilled oil. Attached to the large garage area, START personnel observed five storage rooms. Within the storage rooms, START personnel observed two 55-gallon steel drums containing virgin motor oil, three 55-gallon steel drums containing waste motor oil, six 5-gallon buckets of roof sealant, and roughly 20 gasoline fuel containers (contents unknown) (see Figure 4).

In the North Building, to the north of American Contractors LLC, START observed an area once occupied by a tenant who is currently being evicted. START observed one open-top container/tray which appeared to contain waste motor oil. To the south of American Contractors LLC, START observed a vacated area containing one cylinder estimated by START to be 8-inches in diameter and 48 inches high, and labeled as containing Argon gas (see Figure 4).
